## Differential Pressure Sensors – monitoring the particle filter

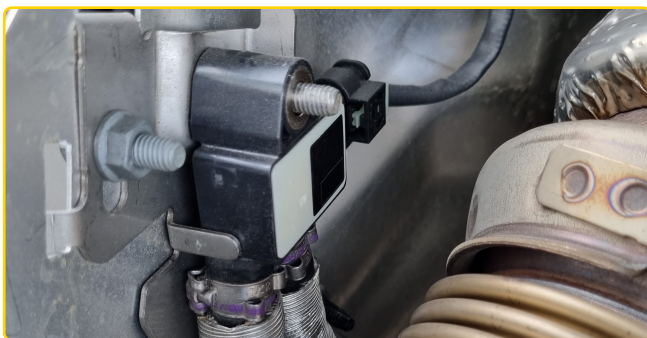
The most common cause of failure is **damage to the tubing** between the sensor and filter. In modern vehicles, the hoses are rarely completely visible or easily accessible!

The tubing can be damaged by animal bites or, with advancing age, become porous, leaky and soft, so that it may contract and block the flow completely under slight negative pressure.
